Debris/Ice/TPS Assessment And Integrated Photographic Analysis For Shuttle Mission STS-49

July 1992

Shuttle Mission STS-49 was launched at 7:40 p.m. local 5/7/92

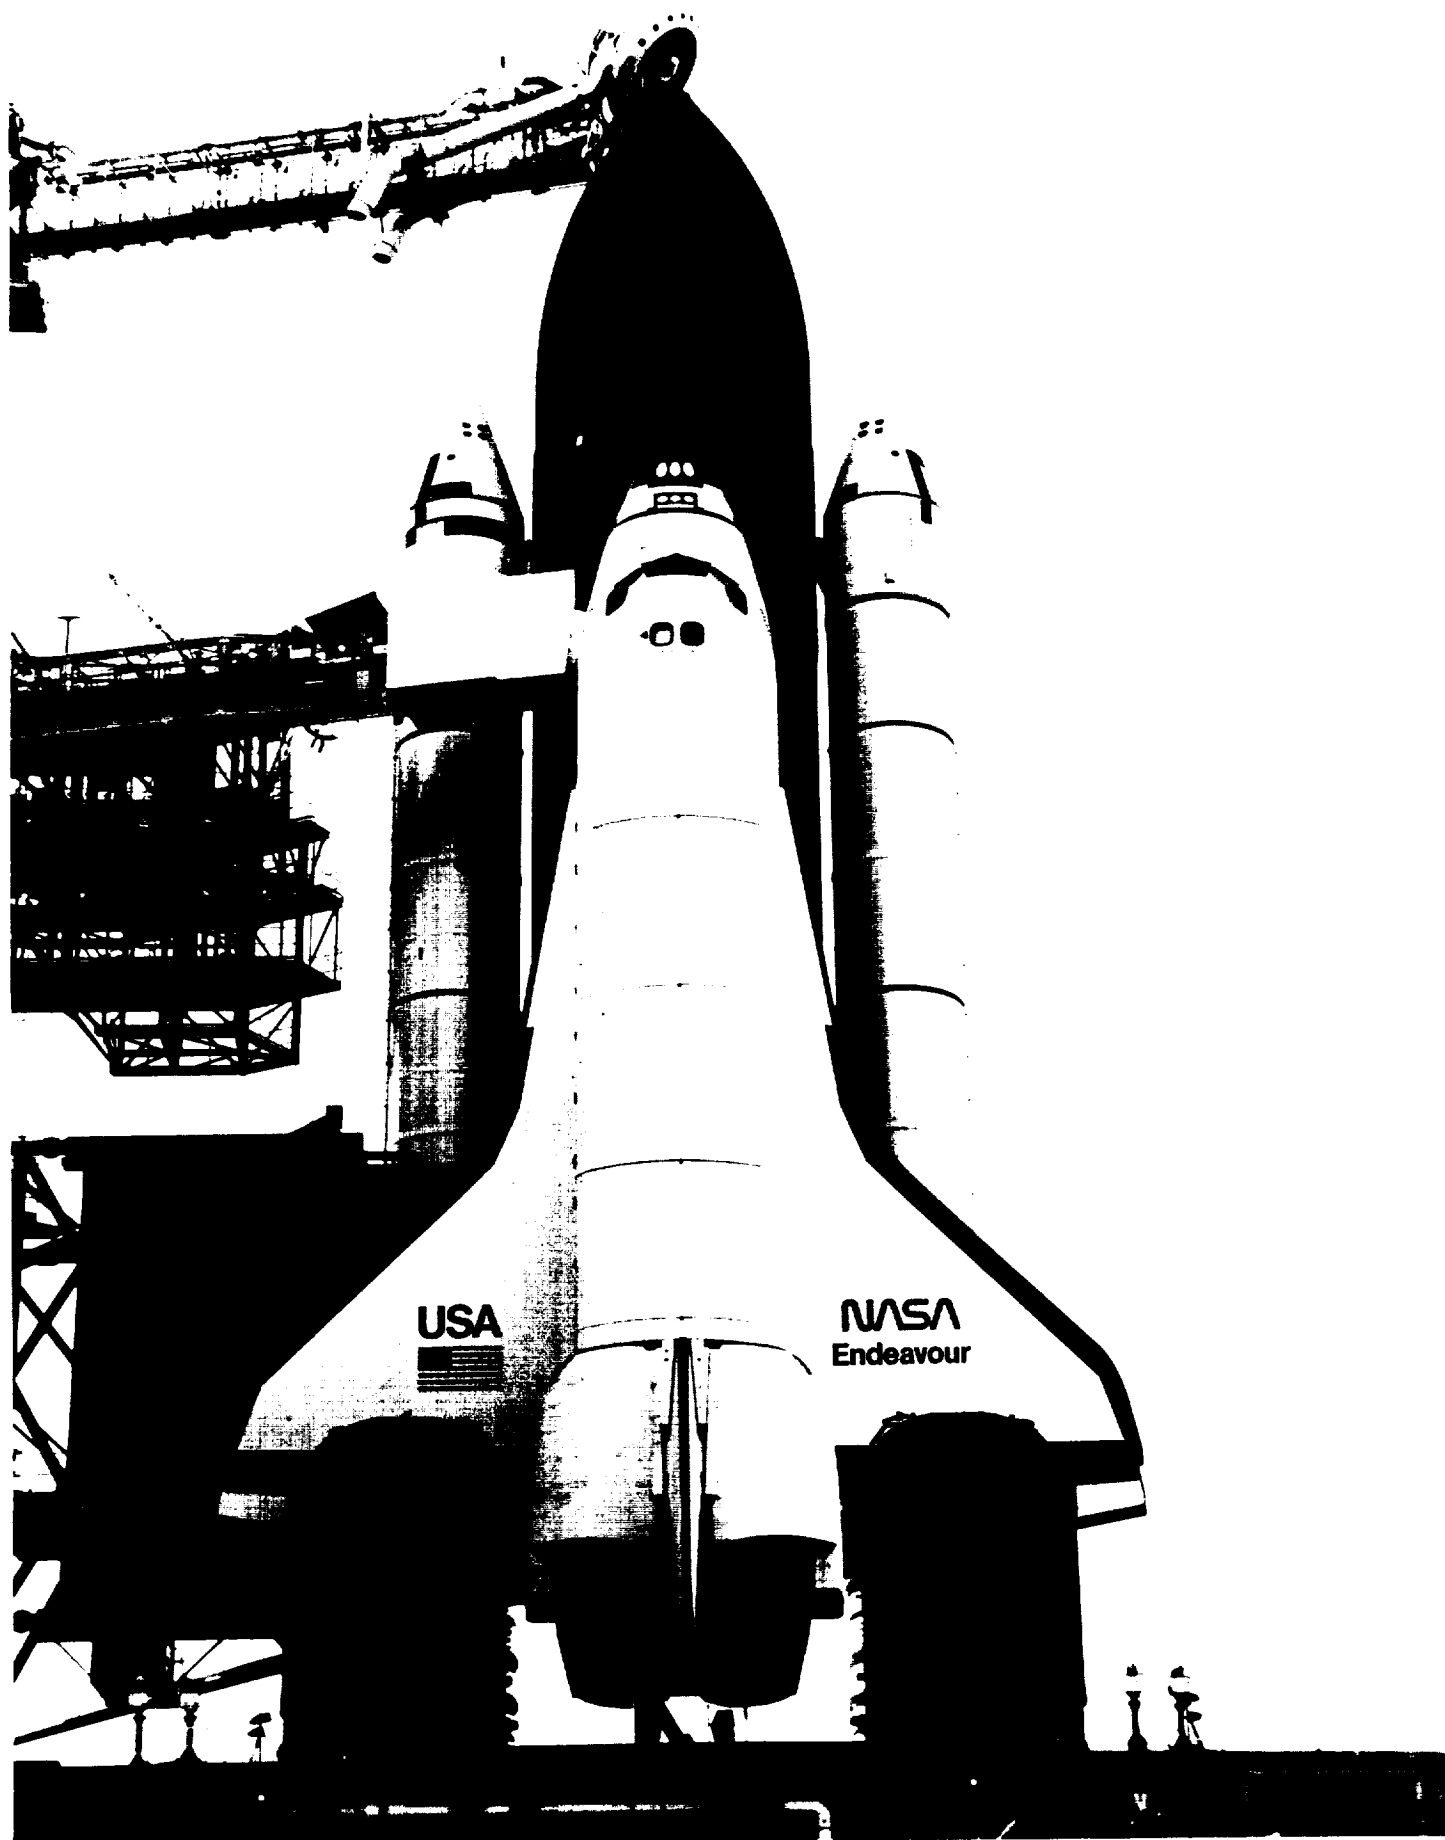
OV-105 Endeavour (1st flight), ET-43 (LWT 36), BI-050 SRBs

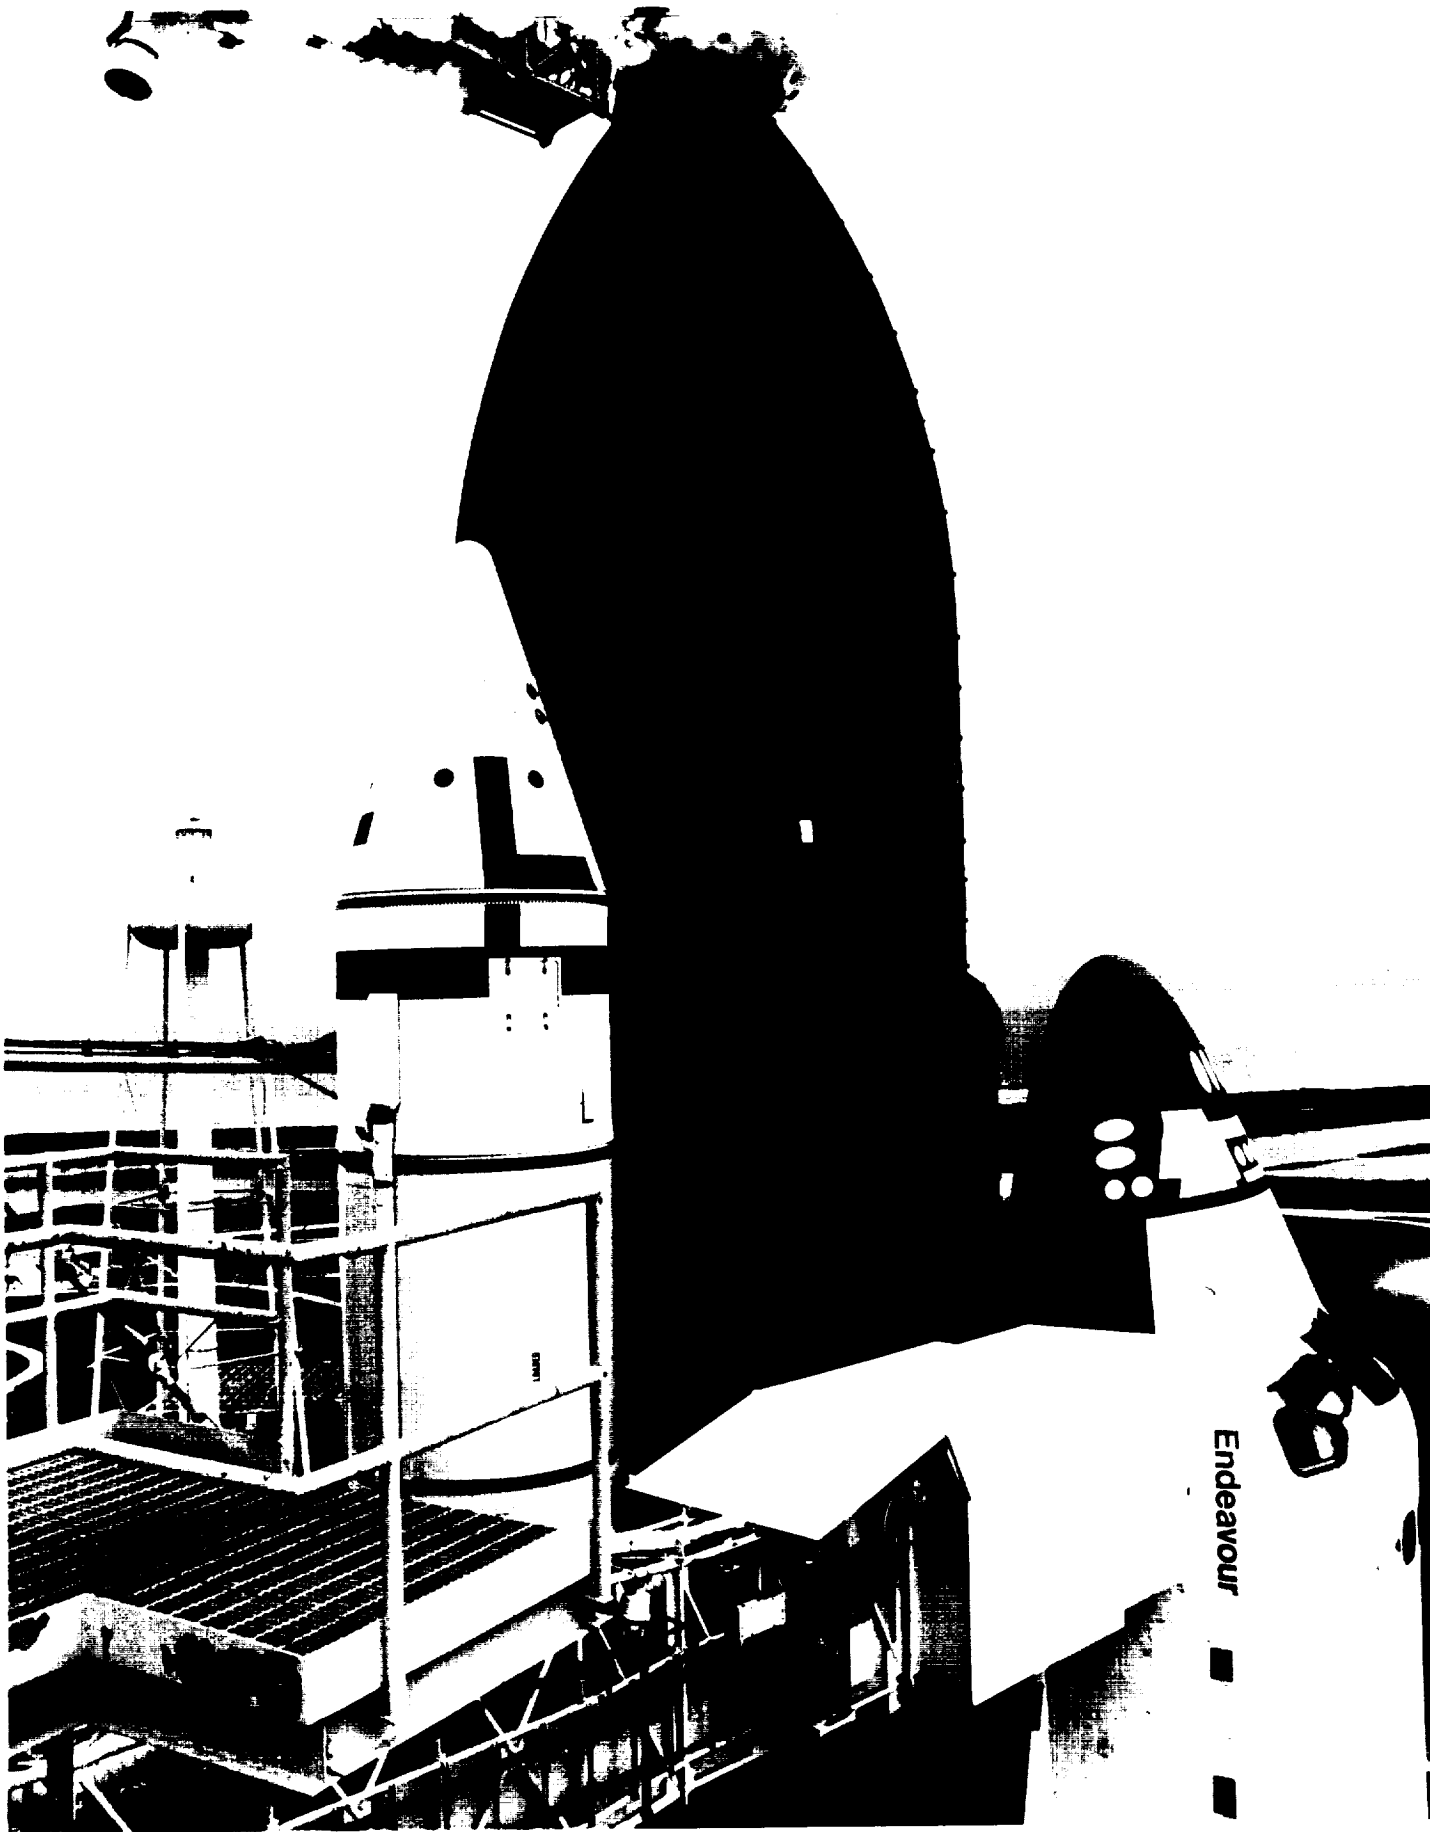
Light condensate, but no ice, frost, or TPS anomalies, were present on the acreage of the LO2 tank ogive and barrel section

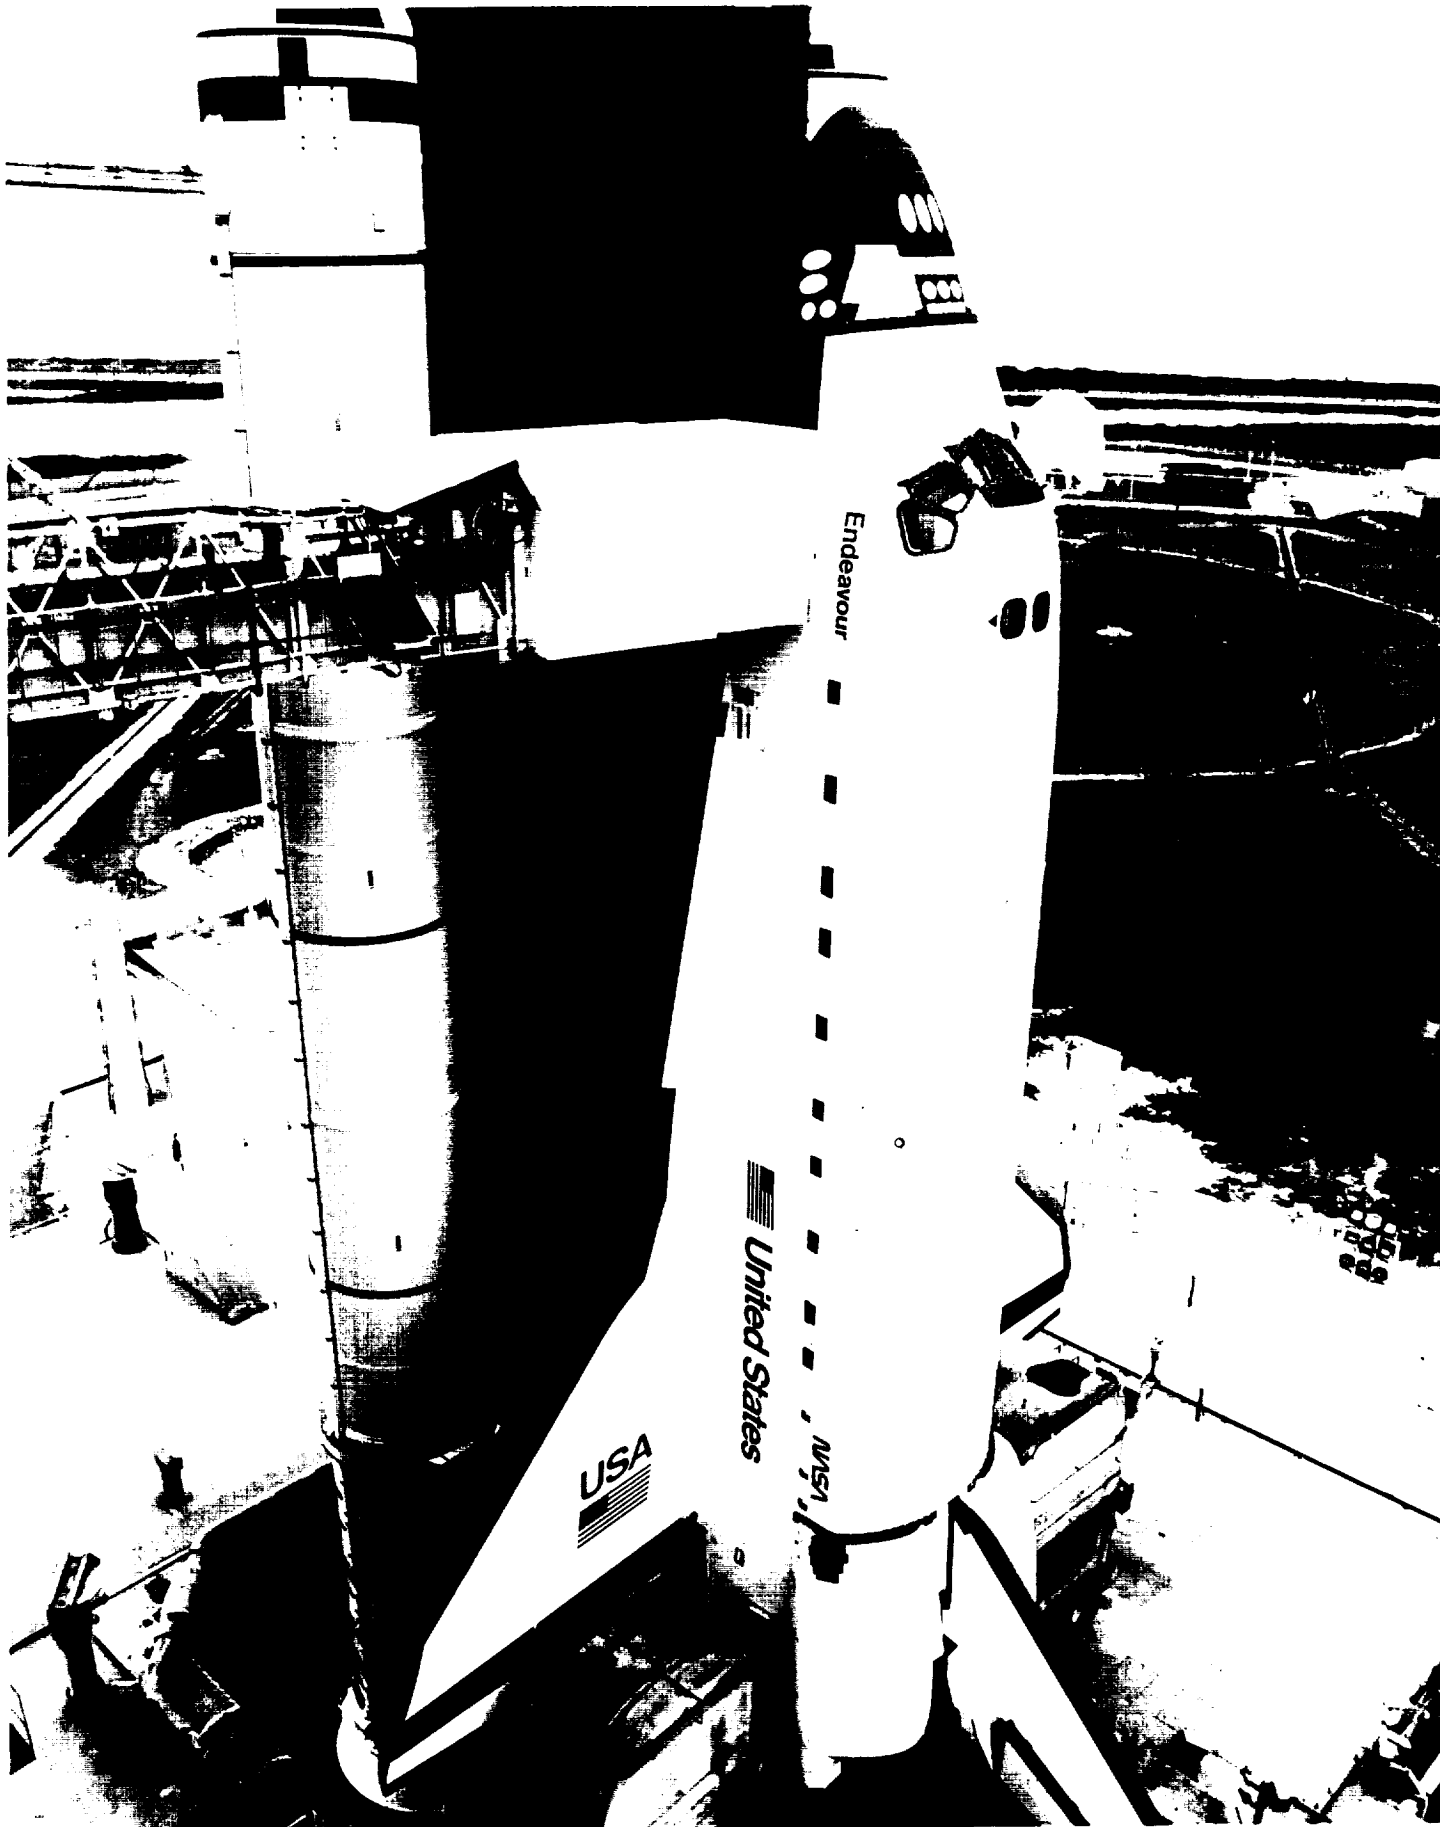
Light condensate, but no ice, frost, or TPS anomalies, were present on the LH2 tank acreage and aft dome. There were no SRB or Orbiter anomalies.

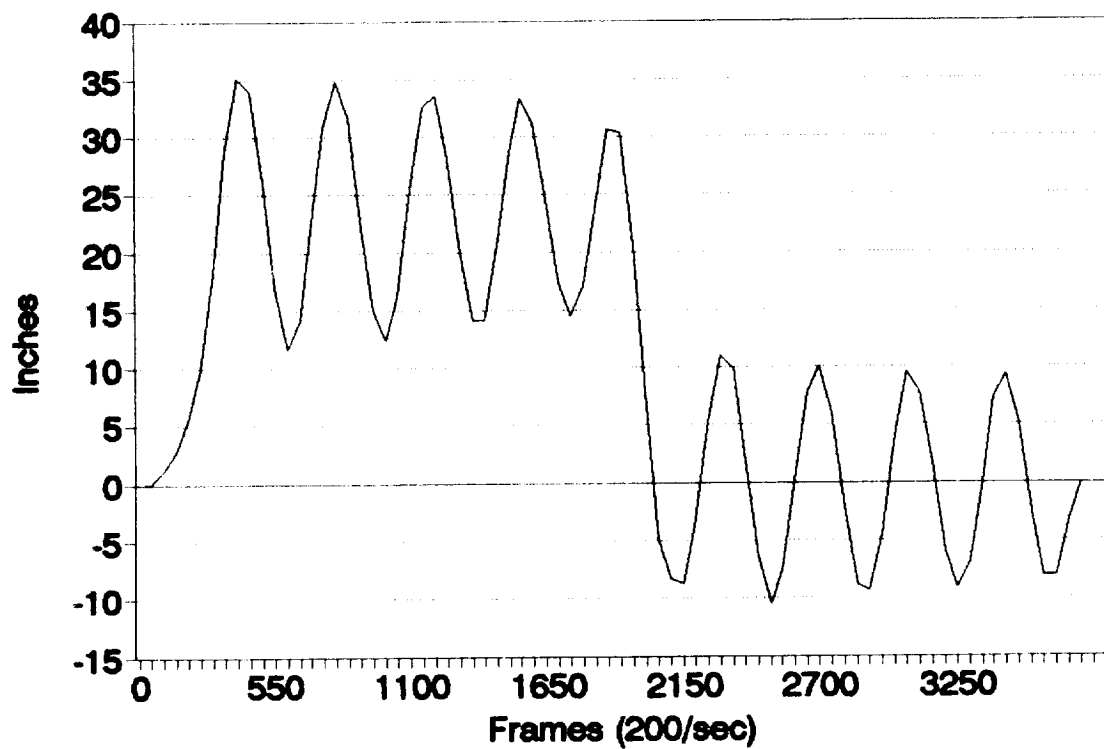
Figure 6. **ET Tip Deflection**
STS-49 FRF

caused the vehicle to oscillate between the plus 10-inch and minus 10-inch marks. Total excursion of the ET spike during the FRF was 45 inches (Reference Figure 6).

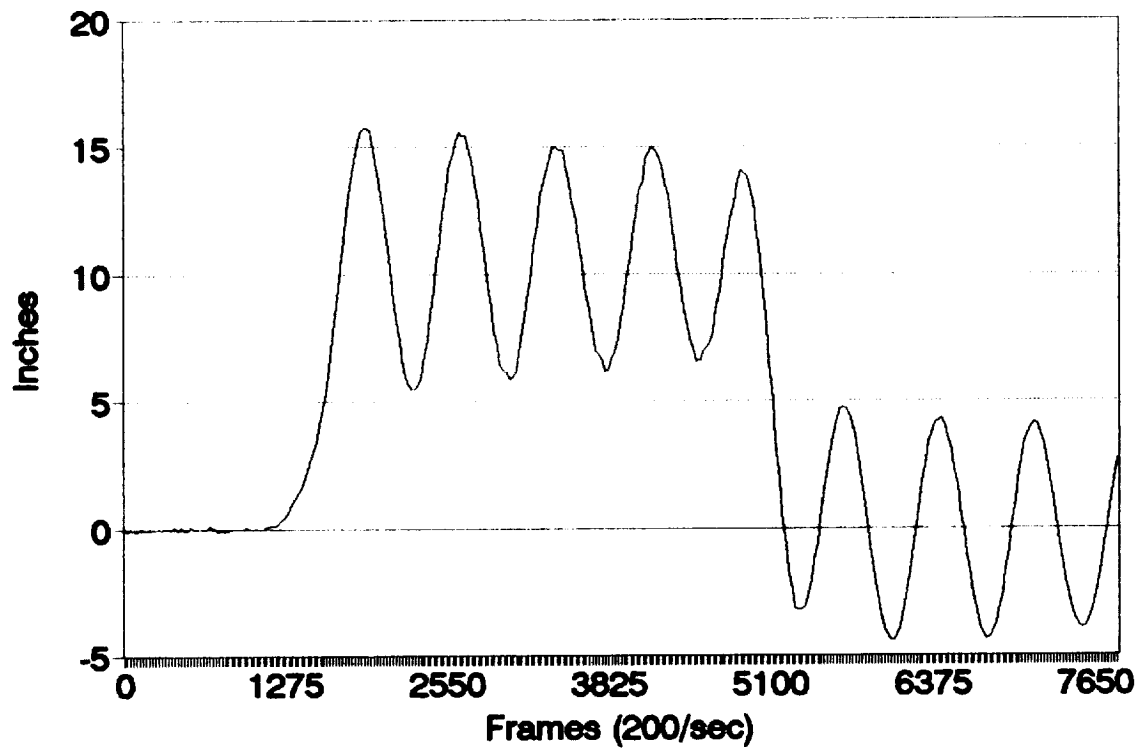
Figure 7. **LH2 Gucp Deflection**
STS-49 FRF

Excursion of the ET at the GUCP followed a similar pattern, but with smaller amplitudes, to the nosecone deflection (reference Figure 7).

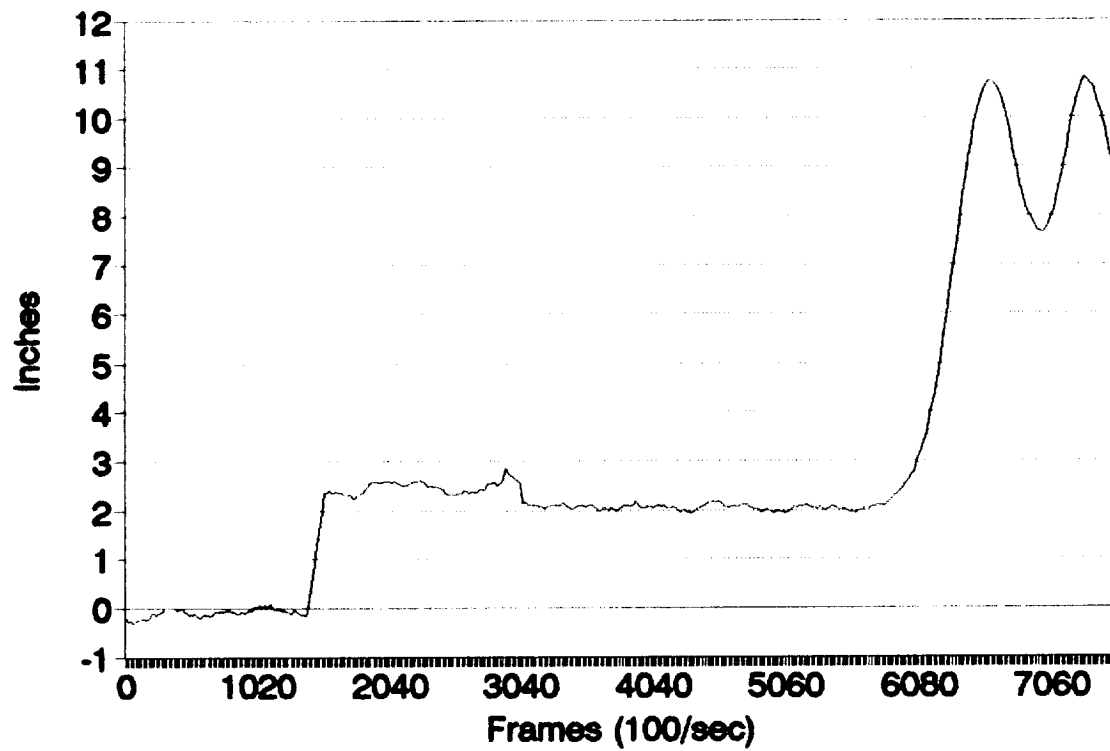
Figure 8.

The TSM LO2 T-0 umbilical had been instrumented with position measuring devices to measure the umbilical excursion during cryoload and FRF. Data obtained from the devices and from film item E-21 as measured on the S.F.A.T. film analyzer, showed the umbilical had moved downward during slow fill a maximum of 0.44 inches due to the weight of the ET cryogenics. By the end of slow fill, the ET was contracting from the low temperatures, which caused an upward movement. Upon completion of LH2 fast fill, the umbilical had moved upward a maximum of 2.75 inches above the initial pre-cryoload position. Firing of the SSME's during the FRF caused the umbilical to move upward an additional 9 inches reaching a maximum excursion of 10.7 inches (reference Figure 8).

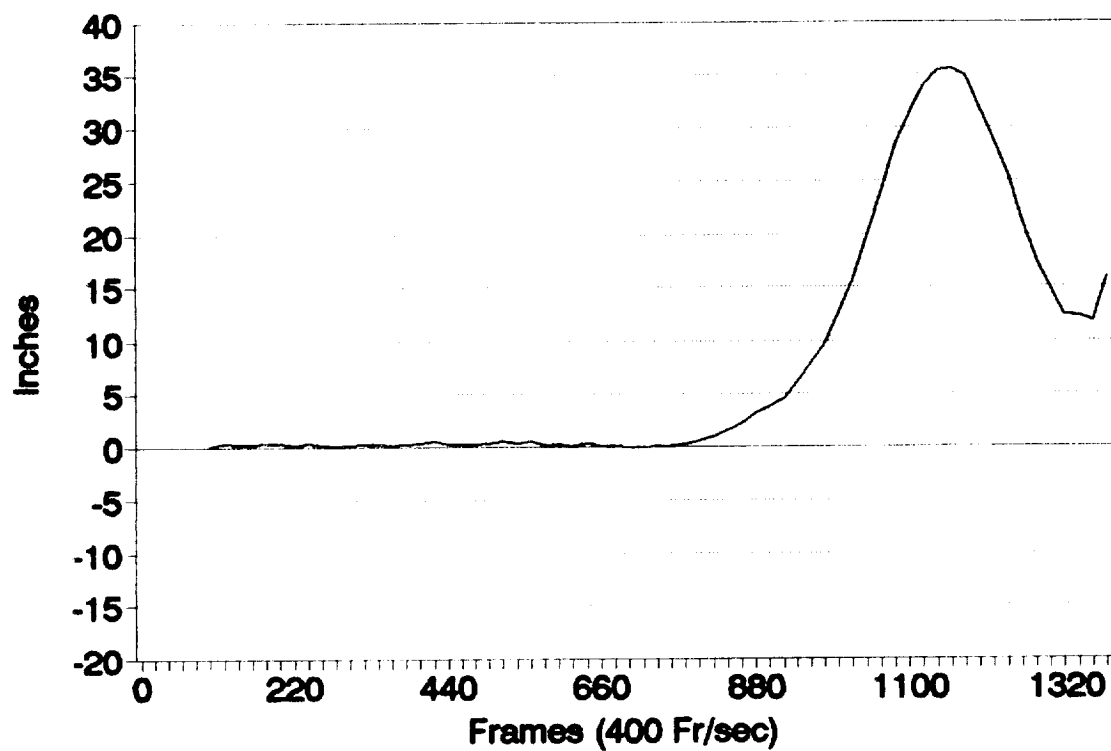
Figure 9. **ET Tip Deflection**
STS-49

ET nosecone deflection, as measured from film item E-79 on the S.F.A.T. film analyzer, was 35 inches at the greatest deflection from the "zero" start position. The vehicle returned to the 12-inch mark before launch (reference Figure 10).

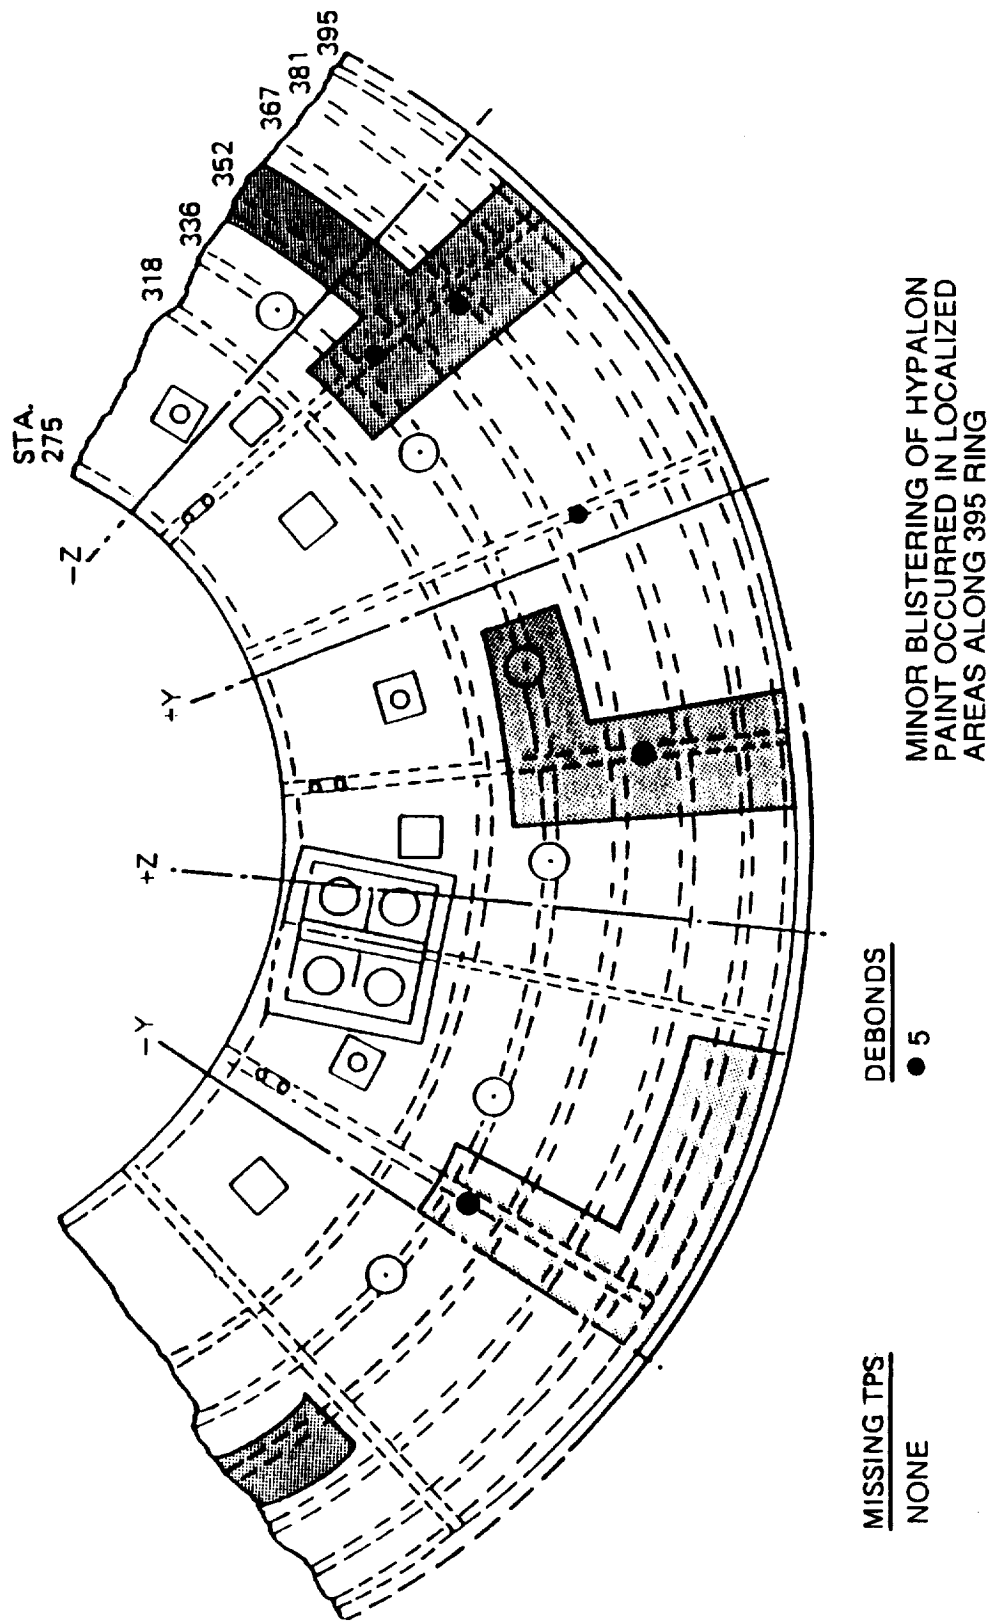
Figure 11. RIGHT SRB FRUSTUM

The RH frustum was missing no TPS but had 5 MSA-2 debonds over fasteners (Figure 11). Minor blistering of the Hypalon paint had occurred along the 395 ring. All BSM aero heatshield covers were locked in the fully opened position. However, two (right side) cover attach rings had been bent at the hinge by parachute riser entanglement.

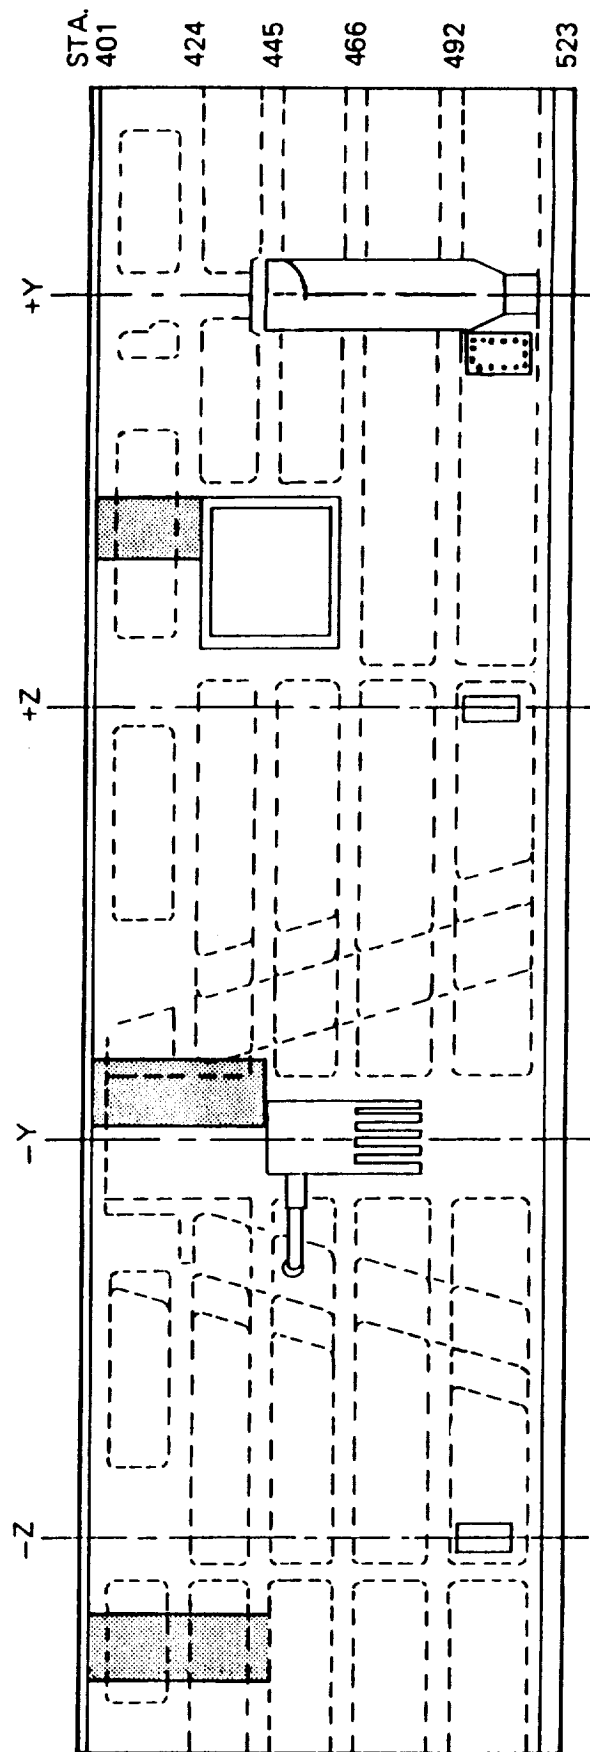
Figure 12. RIGHT SRB FWD SKIRT

The RH forward skirt exhibited no debonds or missing TPS (Figure 12). The phenolic plates on both RSS antennae were intact. Minor blistering of the Hypalon paint occurred on the systems tunnel cover and around the forward attach point. The forward separation bolt and electrical cables appeared to have separated cleanly. No pins were missing from the frustum severance ring.

TPS MISSING
NONE

DEBONDS
NONE

MINOR BLISTERING OF HYPALON
PAINT ON SYSTEMS TUNNEL COVER

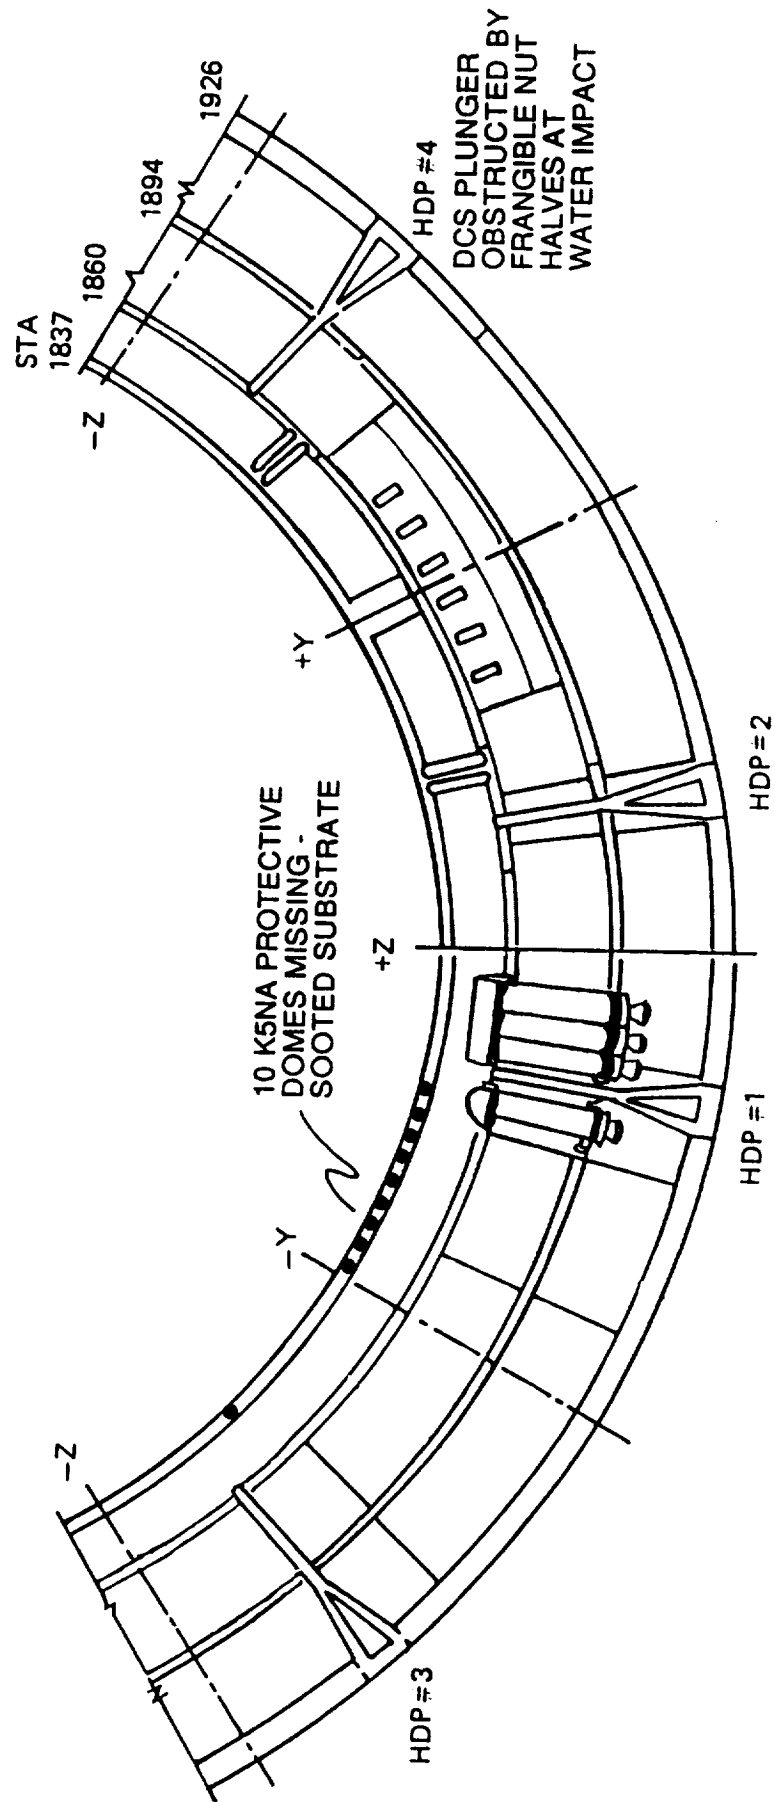
Figure 13. **RIGHT SRB AFT SKIRT EXTERIOR TPS**

The phenolic material on the kick ring had delaminated. Ten K5NA protective domes were lost from bolt heads on the aft side of the phenolic kick ring prior to water impact (sooted substrate). The aft skirt acreage TPS was generally in good condition (Figure 13).

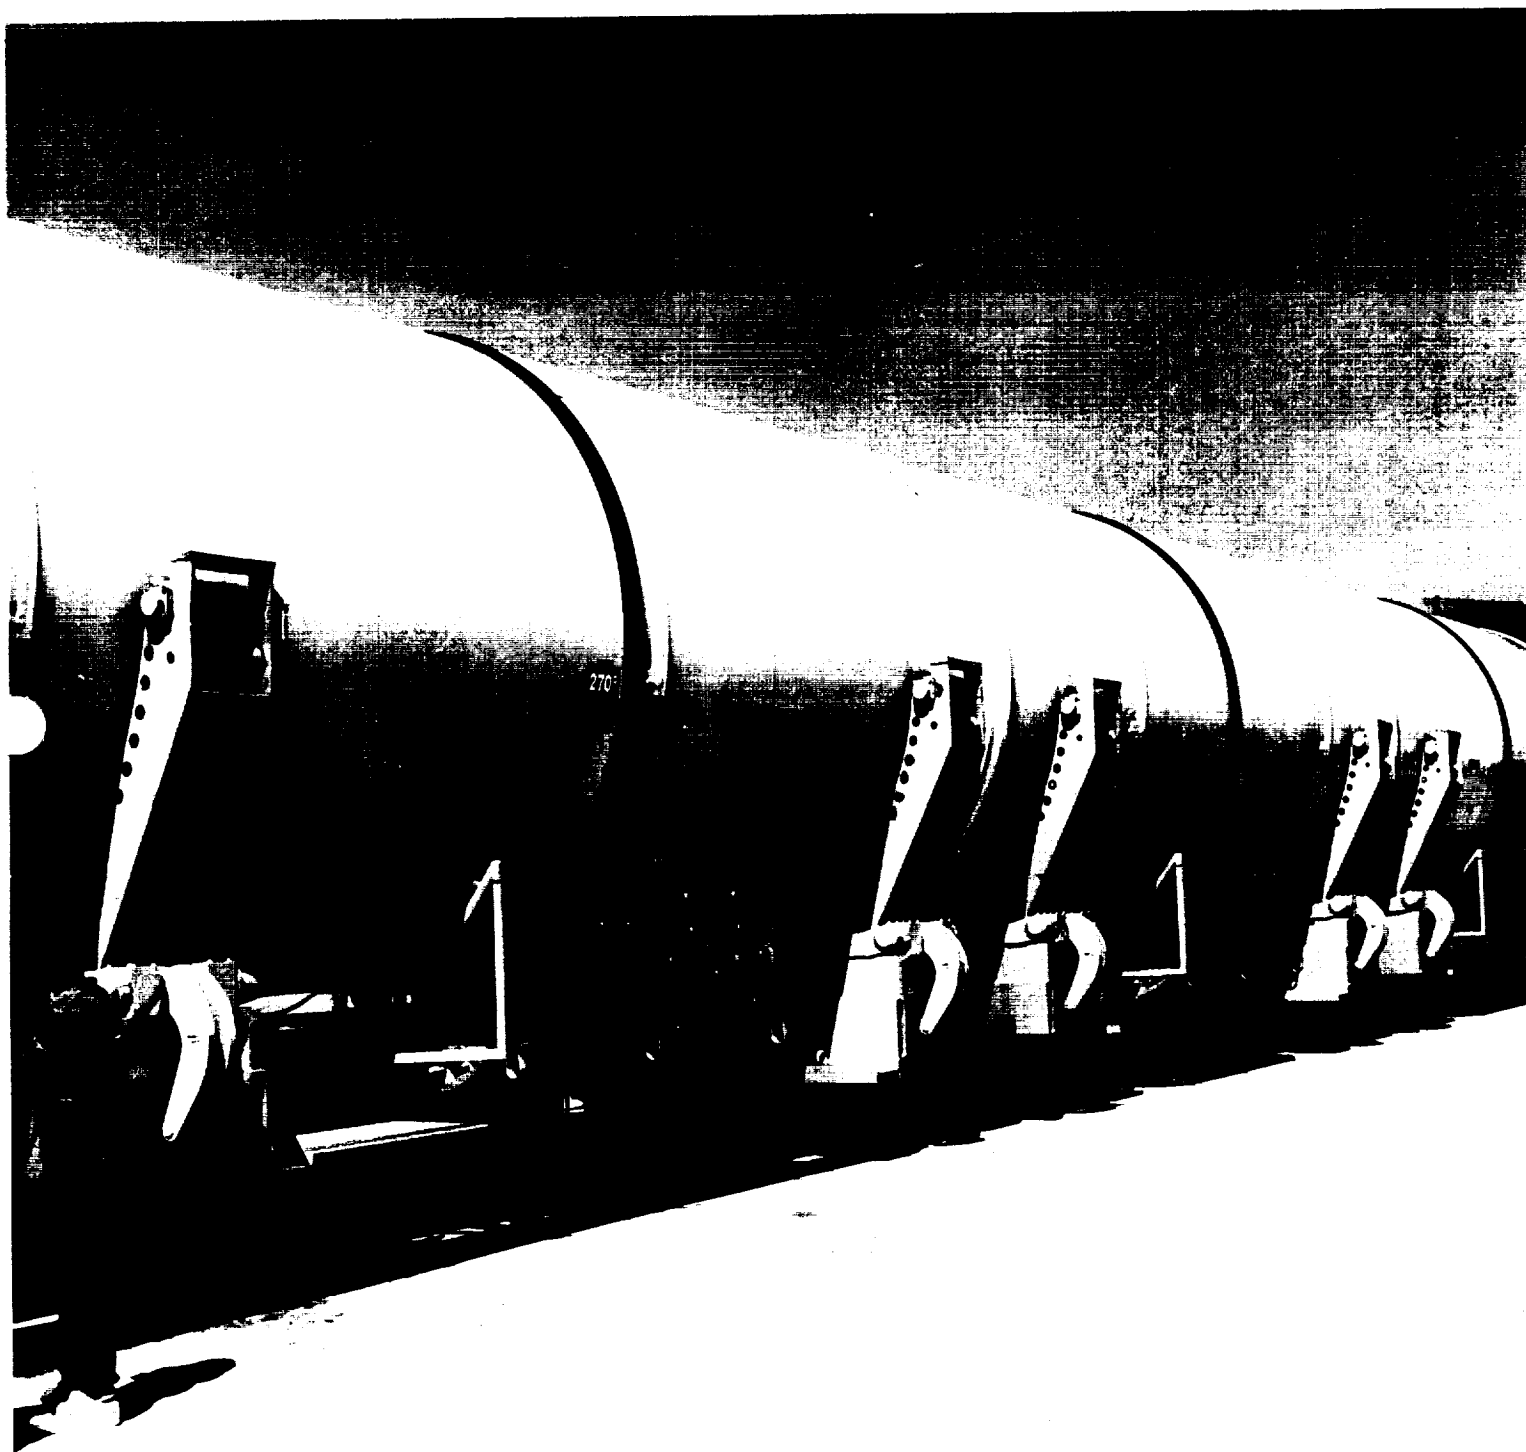
SRM segment cases, Field Joint Protection System (FJPS), and GEI cork run closeouts were in good condition.

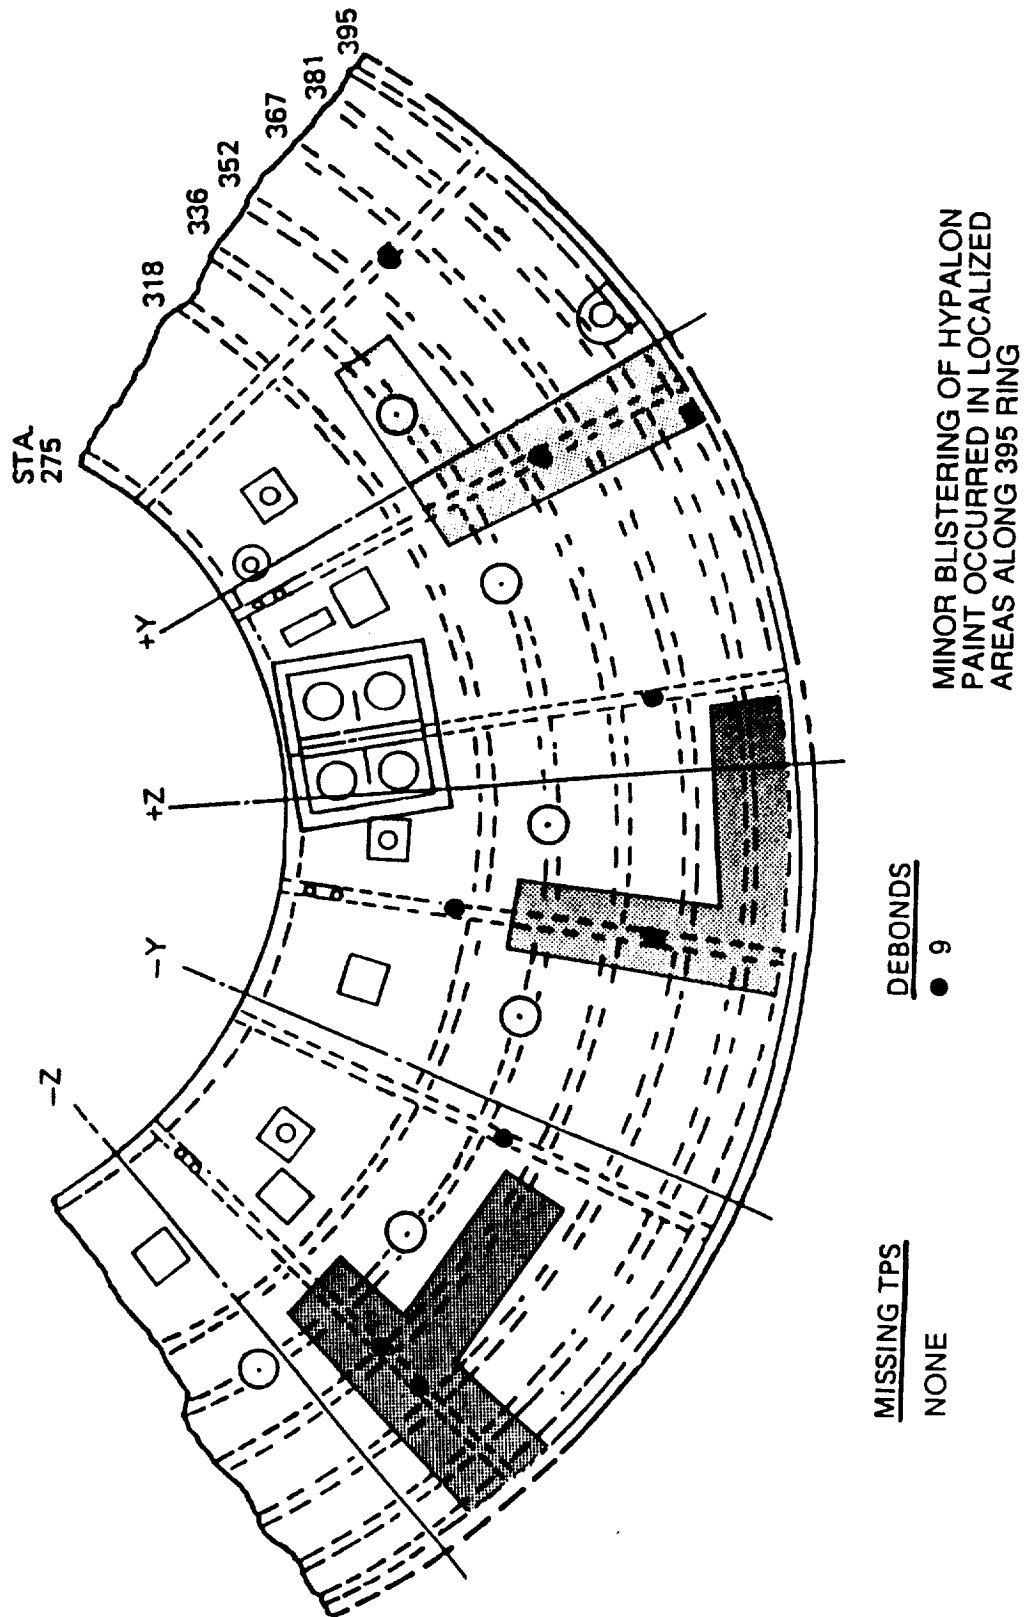
Figure 14. LEFT SRB FRUSTUM

The LH frustum was missing no TPS but had 9 MSA-2 debonds over fasteners. There was minor localized blistering of the Hypalon paint (Figure 14). The BSM aero heatshield covers were locked in the fully opened position.

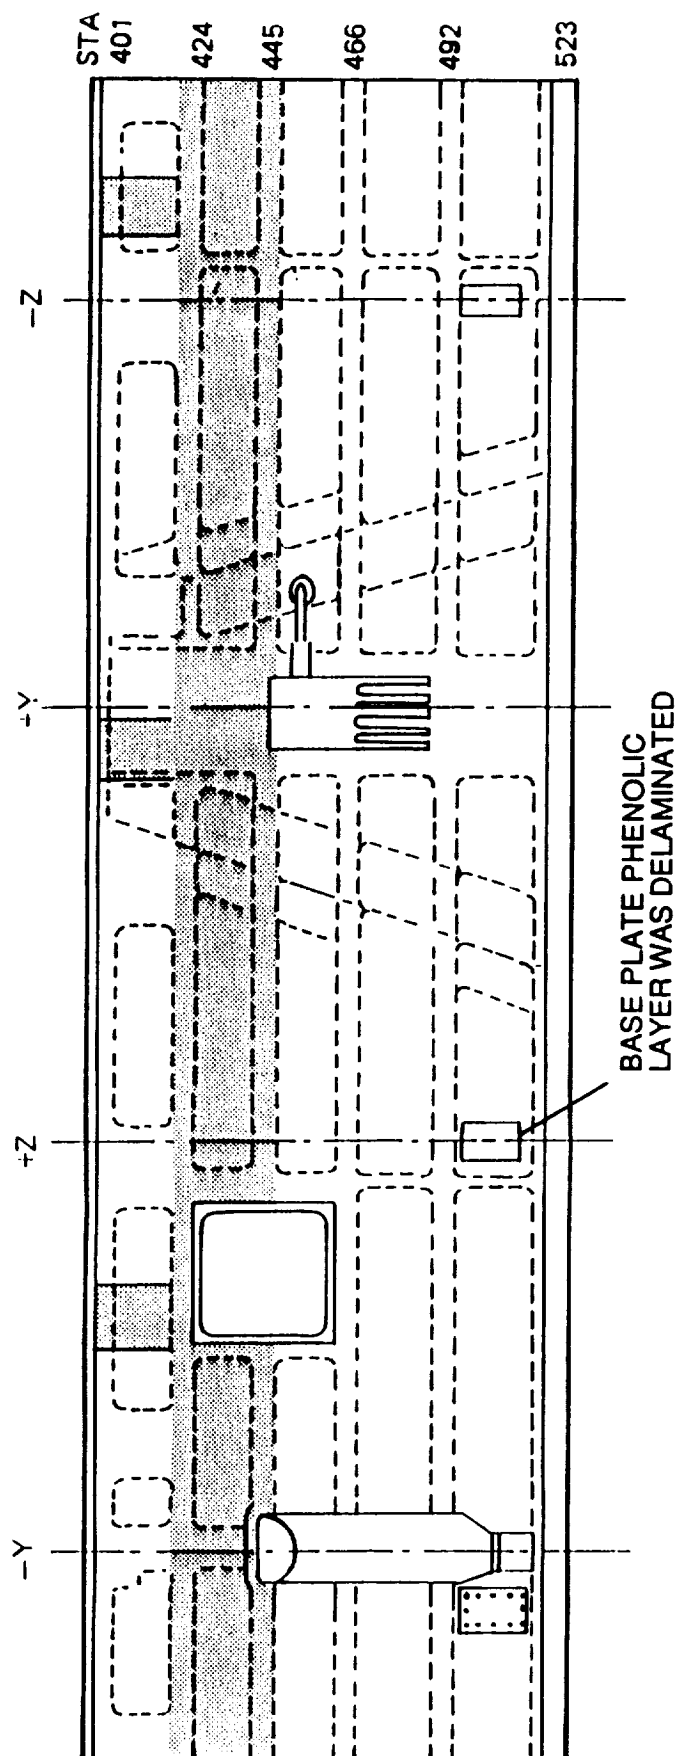
Figure 15. **LEFT SRB FWD SKIRT**

The LH forward skirt exhibited no debonds or missing TPS. The phenolic plates on both RSS antennae were intact though the material on the +Z antenna plate had delaminated (Figure 15). The forward separation bolt and electrical cables appeared to have separated cleanly. No pins were missing from the frustum severance ring. Minor blistering of the Hypalon paint occurred near the ET/SRB attach point and on the systems tunnel cover.

TPS MISSING	DEBONDS
<u>NONE</u>	<u>NONE</u>

MINOR BLISTERING OF HYPALON
PAINT OCCURRED ON ET/SRB
ATTACH FITTING AND SYSTEM
TUNNEL COVER

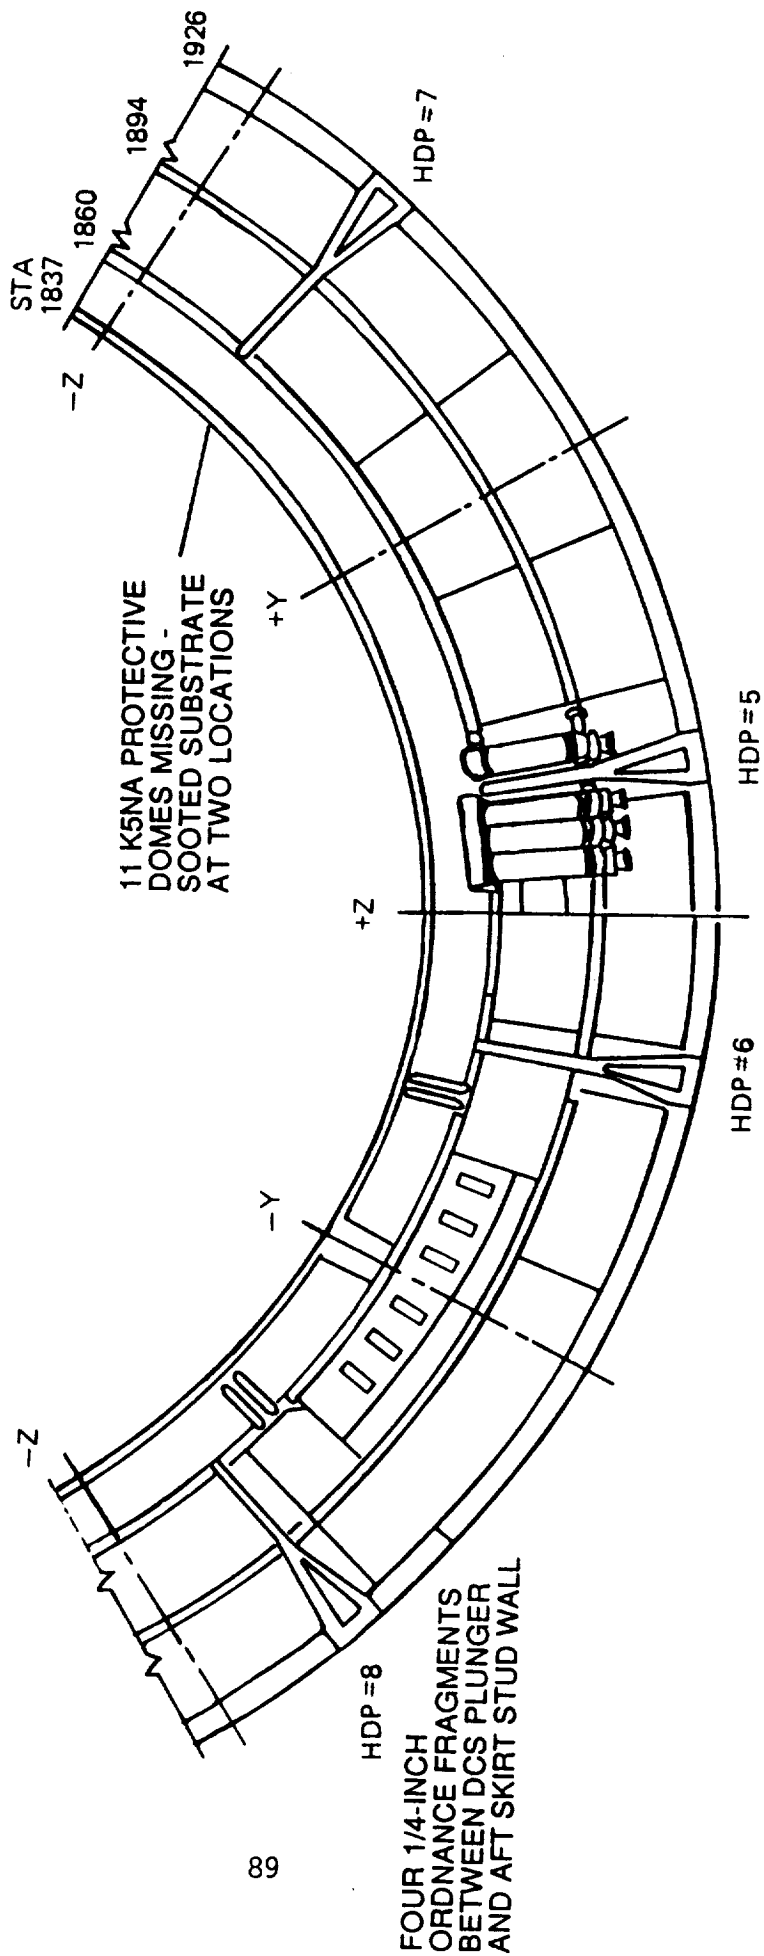
Figure 16. LEFT SRB AFT SKIRT EXTERIOR TPS

Two K5NA protective domes were missing from bolt heads on the aft side of the phenolic kick ring prior to water impact (charred substrate). K5NA was missing from all aft BSM nozzles (Figure 16). The aft skirt acreage TPS was in good condition.
